UniFormat™ B3010 - Roof Coverings.

MasterFormat™ 07 10 00 - Dampproofing and Waterproofing.

## WATERPROOFING FLASHING

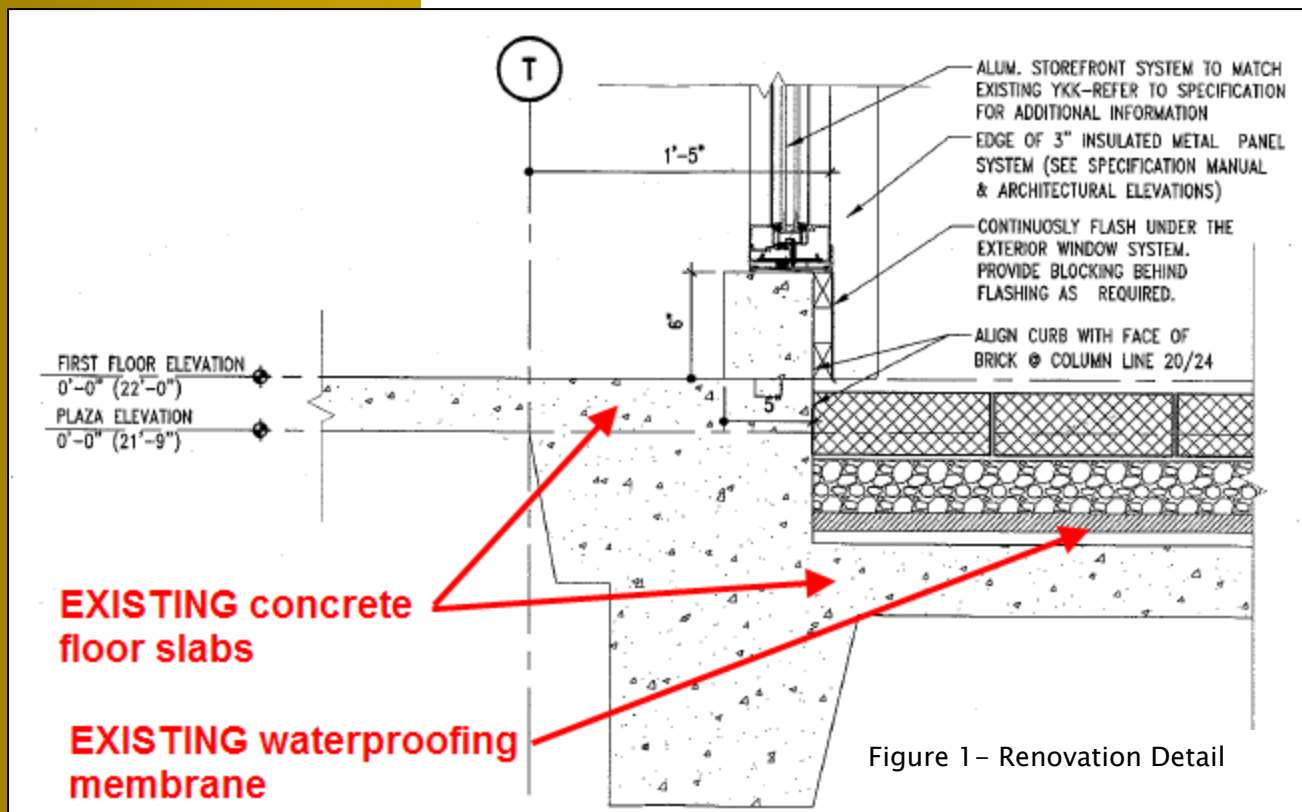
The drawing detail provided for the renovation work identified the new work installed above the concrete floor slab. The detail did not identify the existing construction and did not identify any elements of the plaza. Existing elements should be labeled in details as "existing" as shown in Figure 1 because there will be fewer elements to label as existing compared to the new work. Elements not labeled as "existing" are then considered to be new.

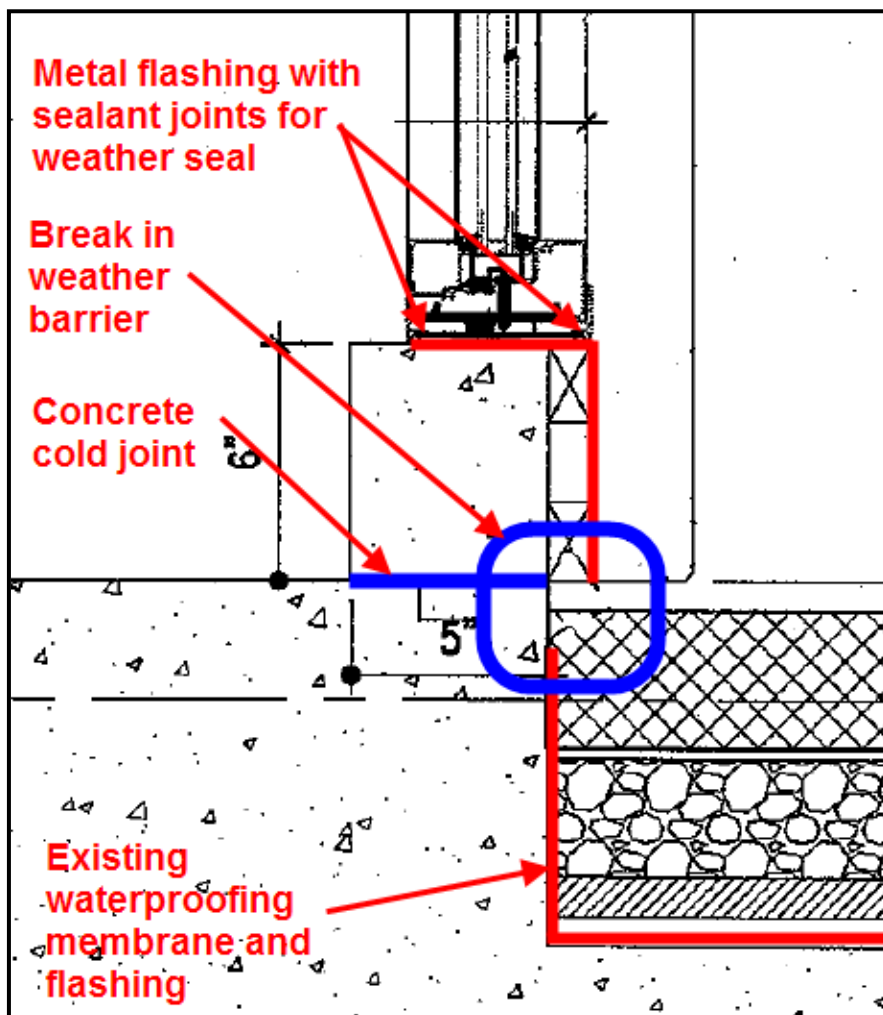
Figure 2 – Weather Barrier Break

The detail does not show the flashing and termination of the waterproofing membrane. The membrane was reported to be turned up the vertical face of the plaza depression and flashed below the new cold joint. The extent of the flashing is shown by red line work in Figure 2. The new pavers provide a surface nearly aligned with the cold joint. Water shed by the exterior wall is deposited onto the pavers at the cold joint. Surface water collected on the pavers can be blown against the joint and make its way into the building.

Because of the building age, the plaza waterproofing may be coal tar or asphalt based. Coal tar was a popular waterproofing choice before the 1970s because of its self healing capabilities. It is important to determine the type of waterproofing materials because coal tar and asphalt are not compatible. Mixing the materials will lead to premature failure.

The sill flashing for the storefront relies on sealants at the interior and exterior surface to complete the weather seal. The flashing does not have a vertical leg at the interior face of the storefront.

Without the vertical leg the flashing end dams at the storefront jambs will be ineffective at preventing water from entering the building when water penetrates the exterior sealant joint.

The principal concern for the detail was determined to be the cold joint and the break in the weather barrier

Install new waterproofing membrane base flashing from the horizontal membrane up the vertical face of the plaza depression. Lap the new flashing over the cold joint onto the new curb and terminate the flashing under the storefront system. Hyload GL waterproofing membrane products were determined to be suitable for the repair. This product is compatible with coal tar membranes. The membrane flashing was sealed to the storefront framing. New sheet metal flashing was installed to conceal the membrane flashing from UV exposure and to provide protection from physical contact
